DSTO-TR-0229

Investigation of Fatigue Cracking
on LAU-7/A Launcher Housing

D.S. Saunders, M.G. Stimson,
R. Bailey and E. Kowal

**Airframes and Engines Division
Aeronautical and Maritime Research Laboratory**

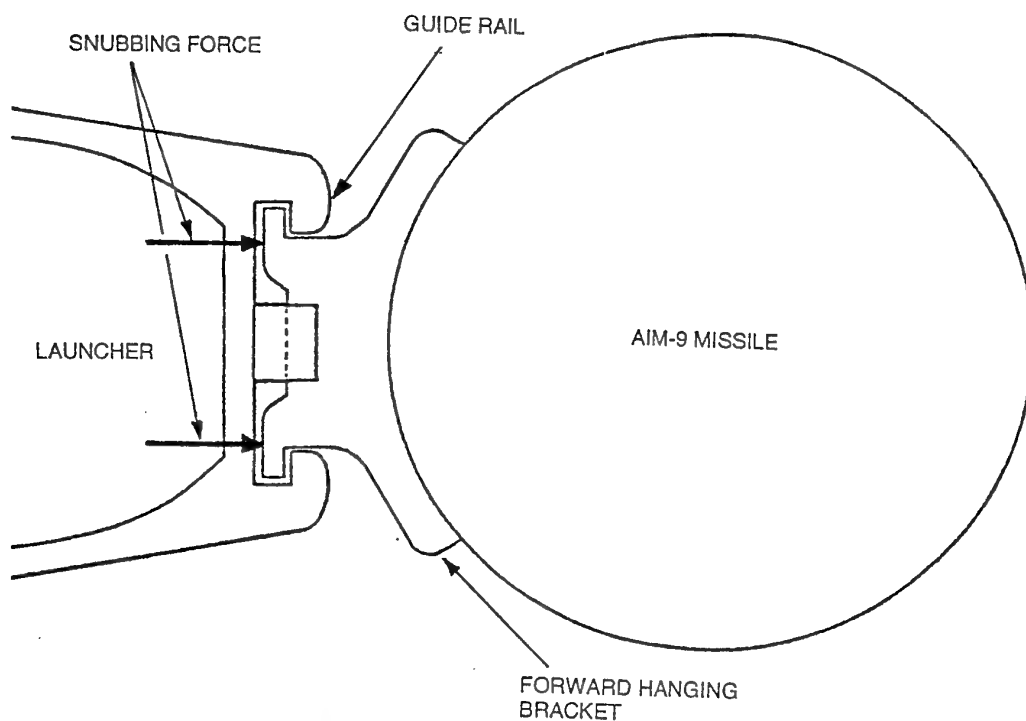
A section through the AIM-9 missile, hanging bracket and LAU-7/A launcher guide rail in the region of the forward hanging bracket is shown in Figure 2. The launchers are extrusions of 2024 aluminium alloy in the T8511 heat treatment condition. Most of the housing wall is of uniform thickness, however in the forward region some machining has been undertaken to increase the internal volume of the housing. The guide rails are on the outer surface of the launcher, Figure 2, and the missile hanging brackets engage the rails at the three locations shown in Figure 1. Snubbing is provided at the aft and forward locations in the guide rails. The aft snubbing is provided by a scissors arrangement, the blades of which engage the hanging bracket lug which then forces the bracket outwards against the inside of the guide rail. The forward snubbing is accomplished by machined steel plates which move (edgewise) onto the forward missile hanger and lock it in the guide rail to prevent lateral and vertical movement of the missile. The edges of these plates are seen in Figure 3, which shows the forward snubber area. The missile is held in the launcher by a detent mechanism activated by leaf springs. The detent must be applied during installation of the missile and is, itself, released on the firing of the missile by the forward thrust of the missile motor. Many of the hanging brackets, both forward and aft, removed from

Figure 2. *Section through the LAU-7/A launcher guide rail and AIM-9 missile at the location of the forward missile hanging bracket.*

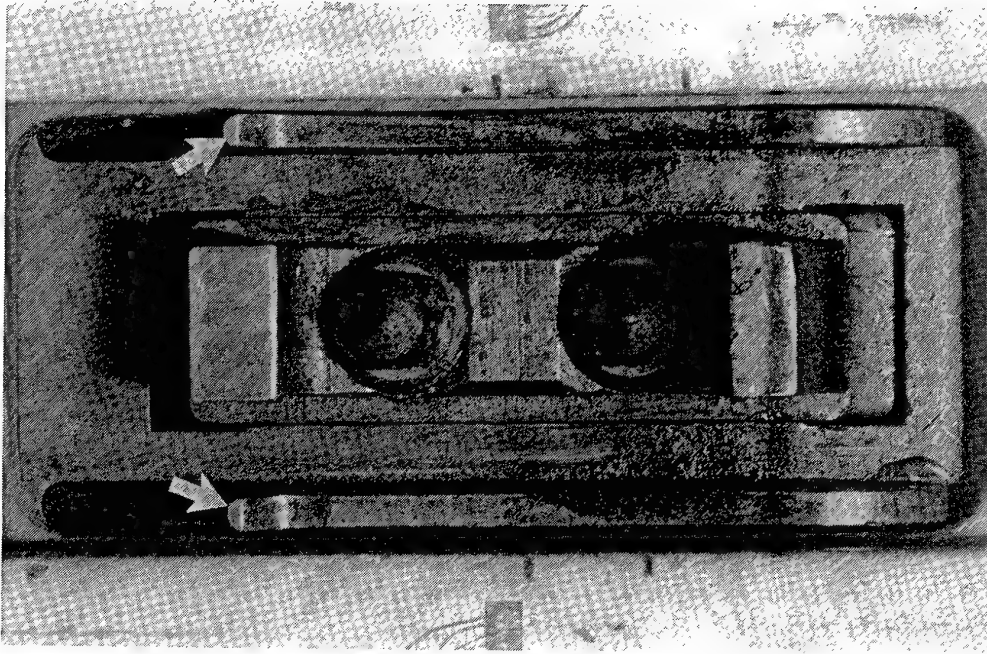
Figure 3. Forward snubber region with forward to the left. The snubber plates (arrowed) are in the engaged position. The hold-back detent mechanism and striker points are visible in the centre.

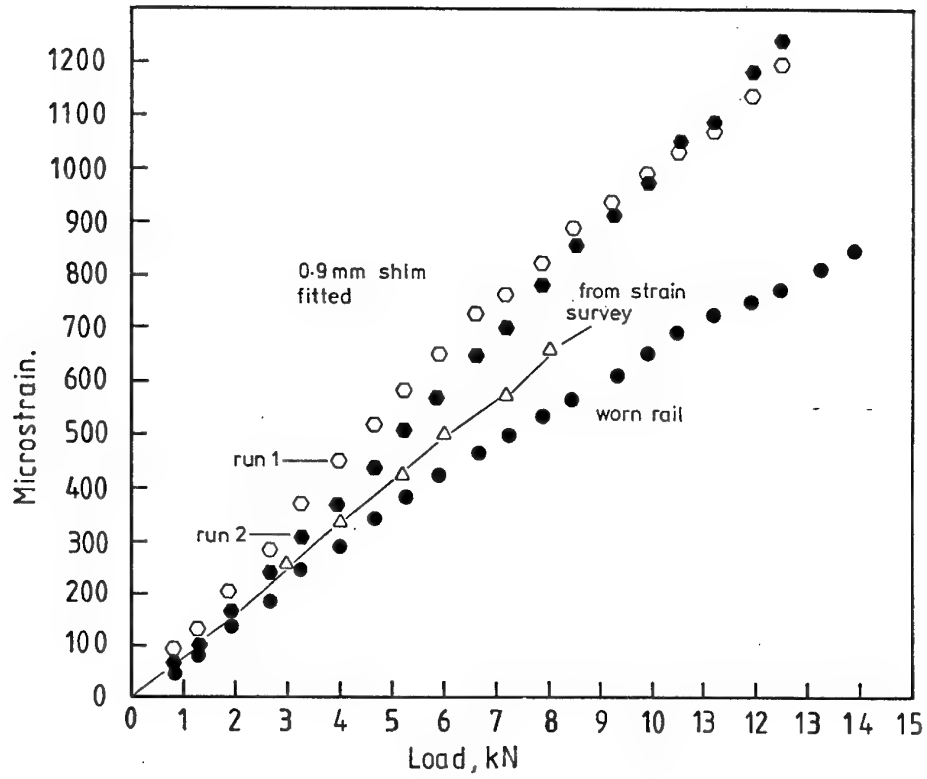
The introduction of a shim at the upper forward hanging bracket location produced higher strains during fatigue testing, see Figure 15, and this appeared to be the result of small geometry changes in the forward hanging bracket region during testing. The small geometry changes may be attributed to wear of the upper guide rail and edges of the lower guide rail where the hanging bracket bears down under the test loading conditions. See Section 5.2 above.

Figure 15. *Effect of shimming forward hanging bracket in the guide rails during a fatigue test.*

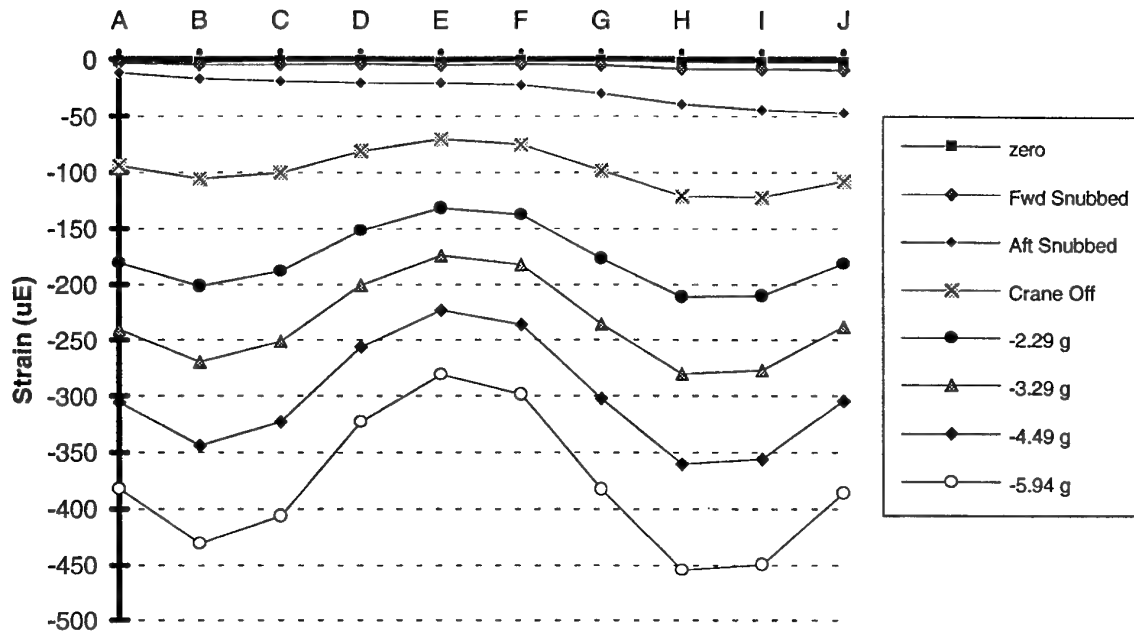
Figure 20. Strain results from the strip gauge on the upper rail during snubbing and subsequent down loading to 5.95g (Experiment 7). The two peaks at gauges B and H lie either side of the line of extension of the crack.

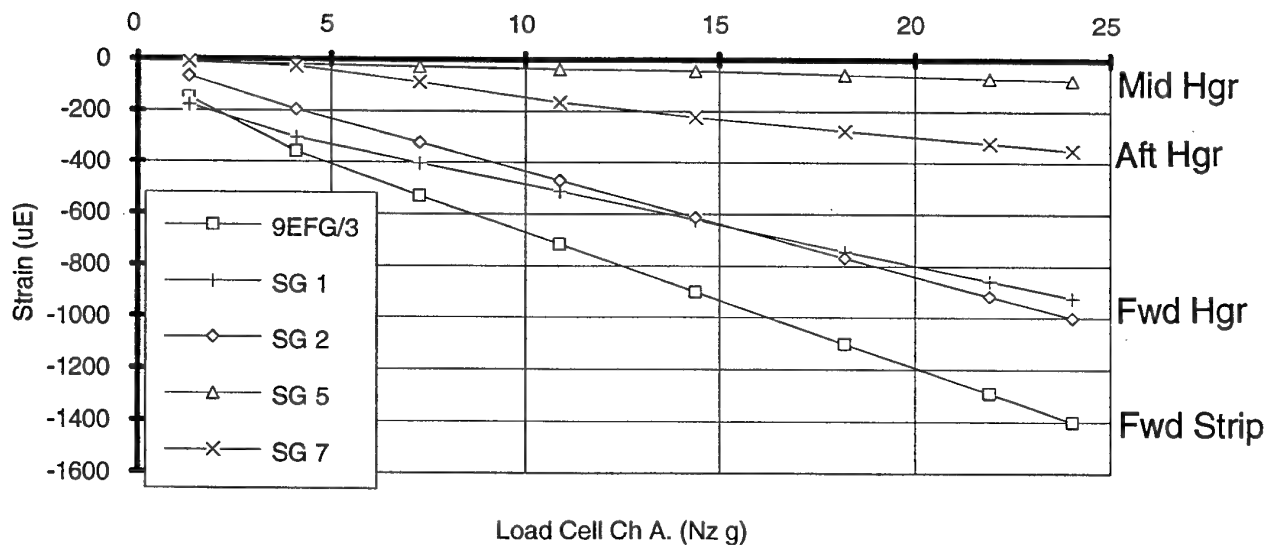
Figure 21. "Load shedding" as seen by comparing the strip gauges (average of E, F and G) at the forward hanger with the single gauges at the mid and aft hangers. These strains are from the loaded rail in Experiment 27.

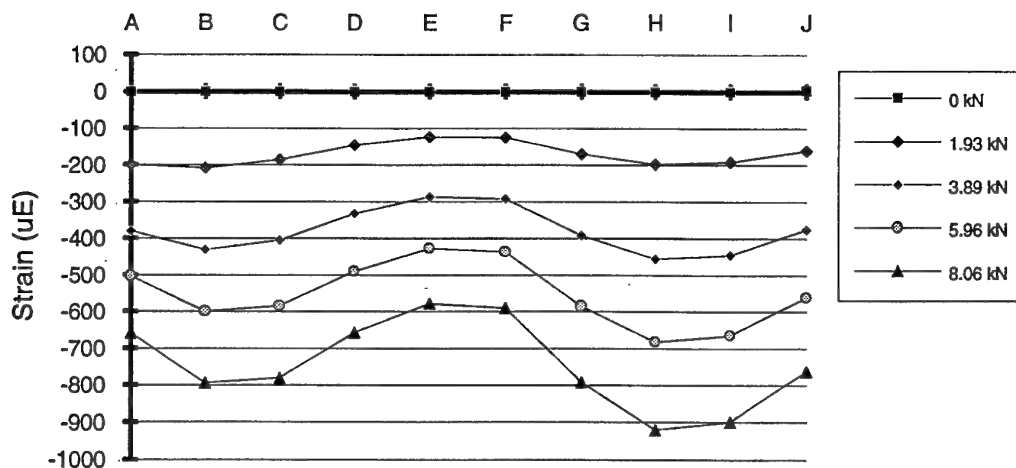
Figure 22 (a). The effect of the crack on strains in the guide rail : Strip gauge strains at the forward snubber on the cracked lower rail during 8.5g up loading of Experiment 5.

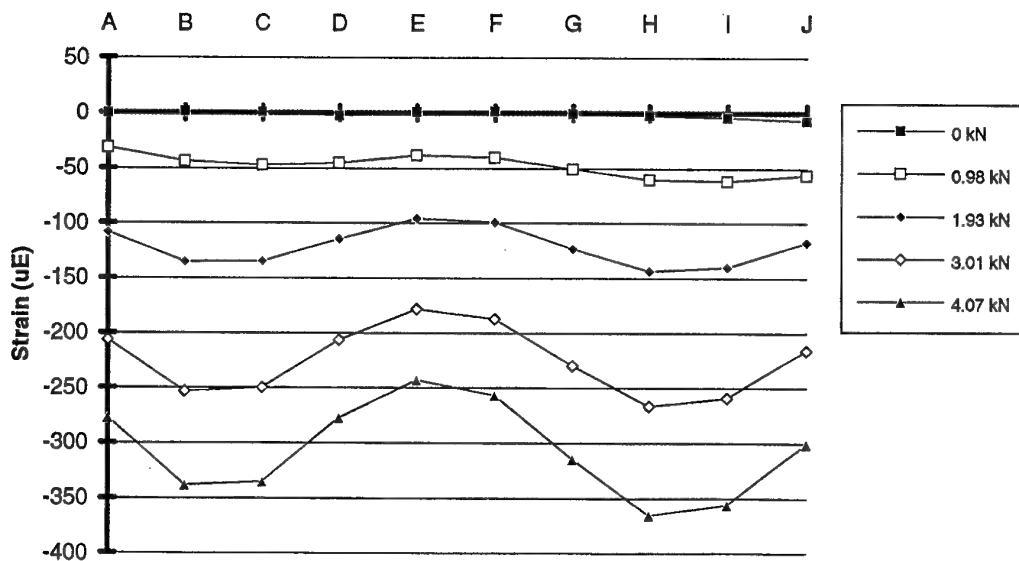
Figure 22 (b). The effect of the crack on strains in the guide rail : uncracked lower rail during up load of Experiment 20.

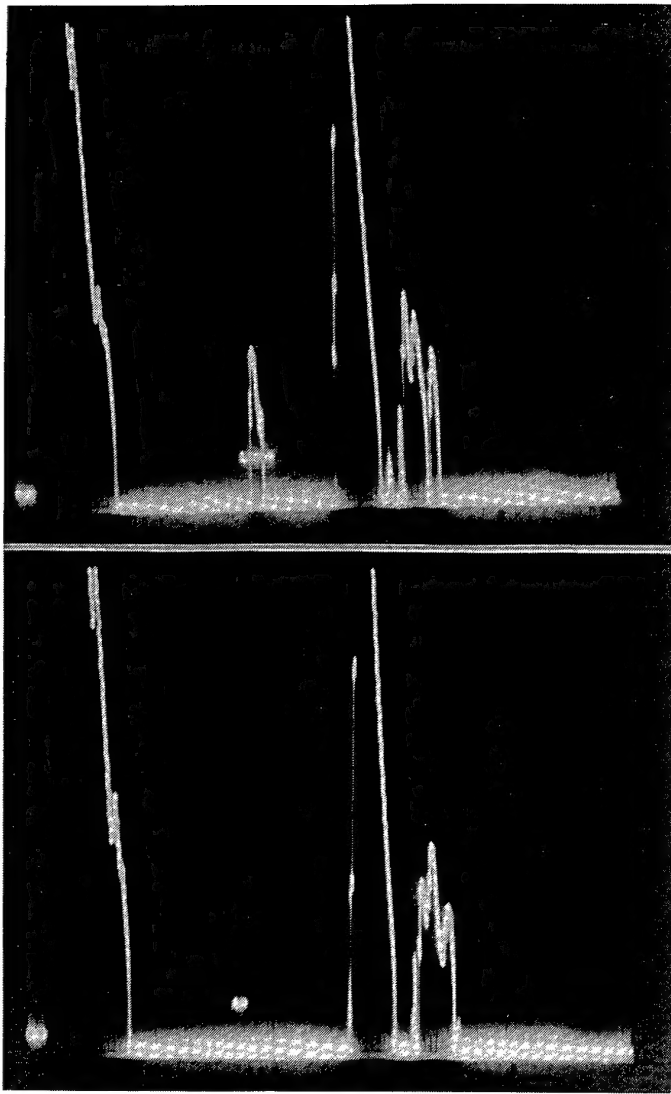
Figure B2.3 The reflection from crack (or artificial defect), within the gate, and outboard corner reflection.
